MIDDLESEX RESERVOIR DAM

PHASE I INSPECTION REPORT

NATIONAL DAM SAFETY PROGRAM

NJ 00377

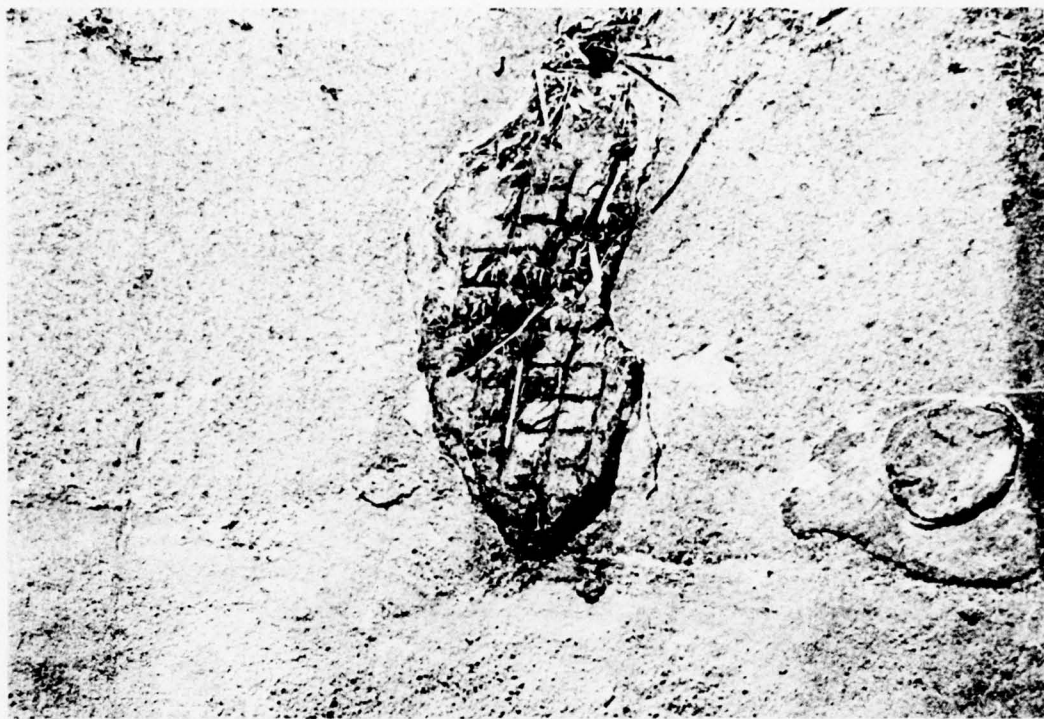
PHOTO 3

Photo 3 - Spalled Area on Spillway Concrete Apron Near Right Wing Wall - 21 June 1978.

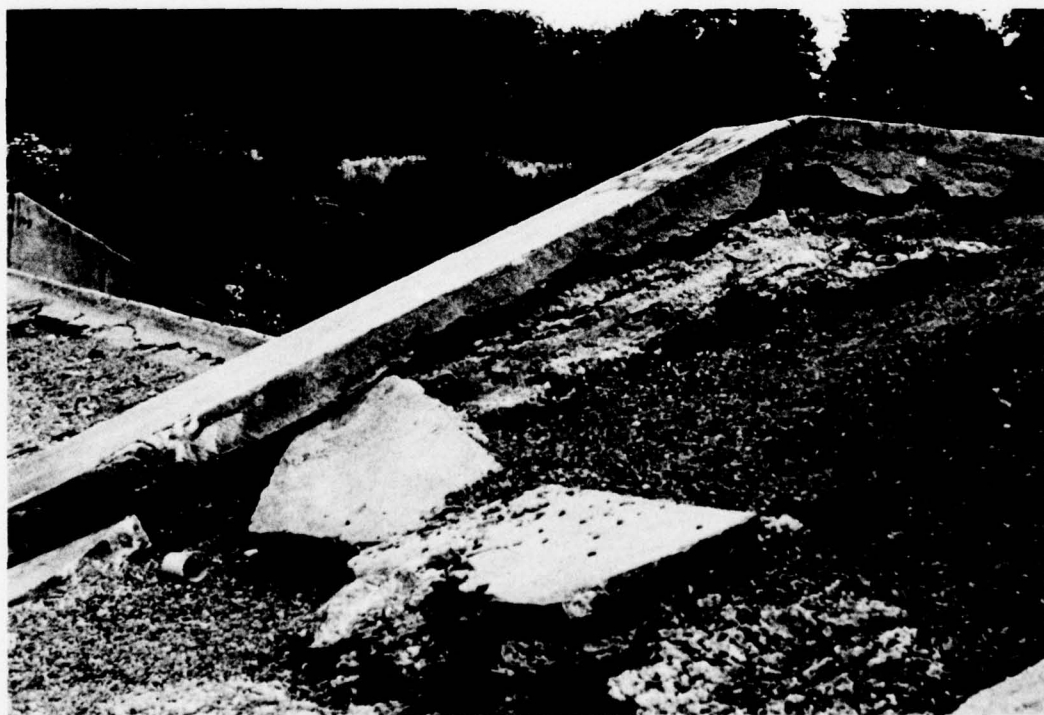
PHOTO 4

Photo 4 - View of Right Wing Wall Showing Guniting Repair and Deteriorated Concrete Below Guniting (Note Eroded Surface of Upstream Embankment Slope and Remains of Concrete Slope Paving on Embankment Slope) - 21 June 1978.

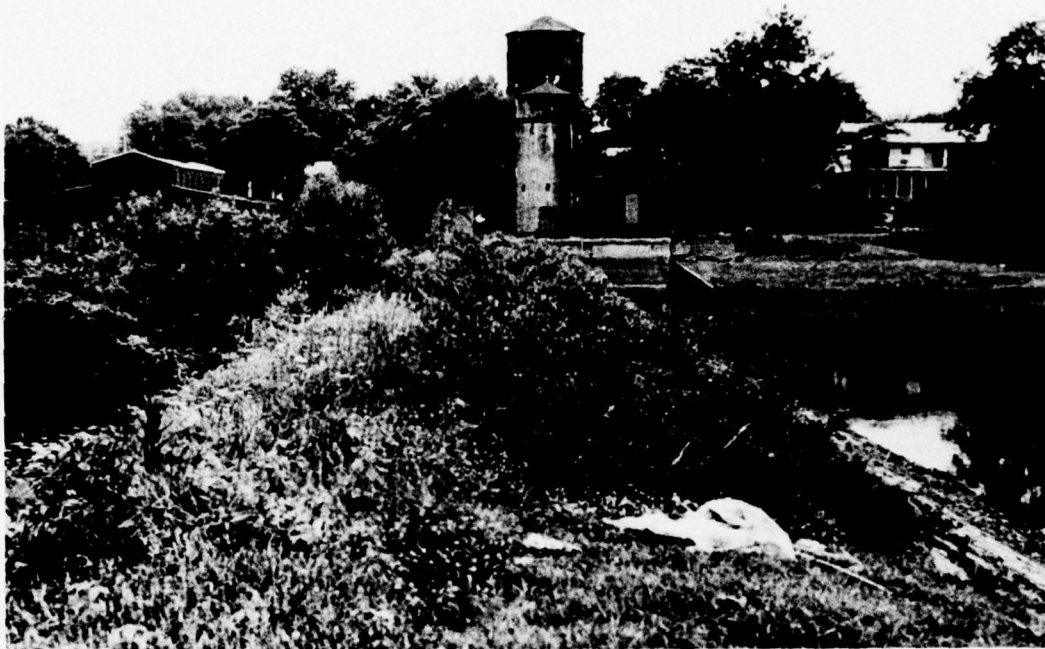
PHOTO 7

Photo 7 - Looking West Across Crest of Embankment Toward Gate House at Right Abutment (Note Small Trees and Brush on Embankment) - 21 June 1978.

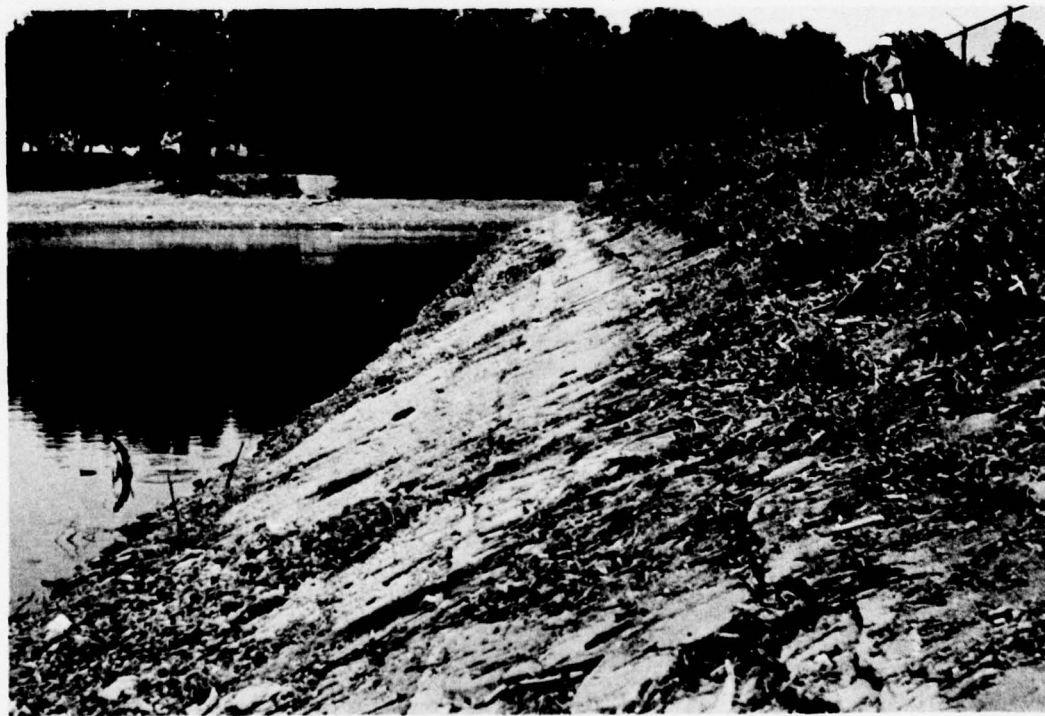
PHOTO 8

Photo 8 - Picture of Deteriorated Concrete Slope Paving on Upstream Side of Embankment (View Is Toward East or Toward Spillway) - 21 June 1978.

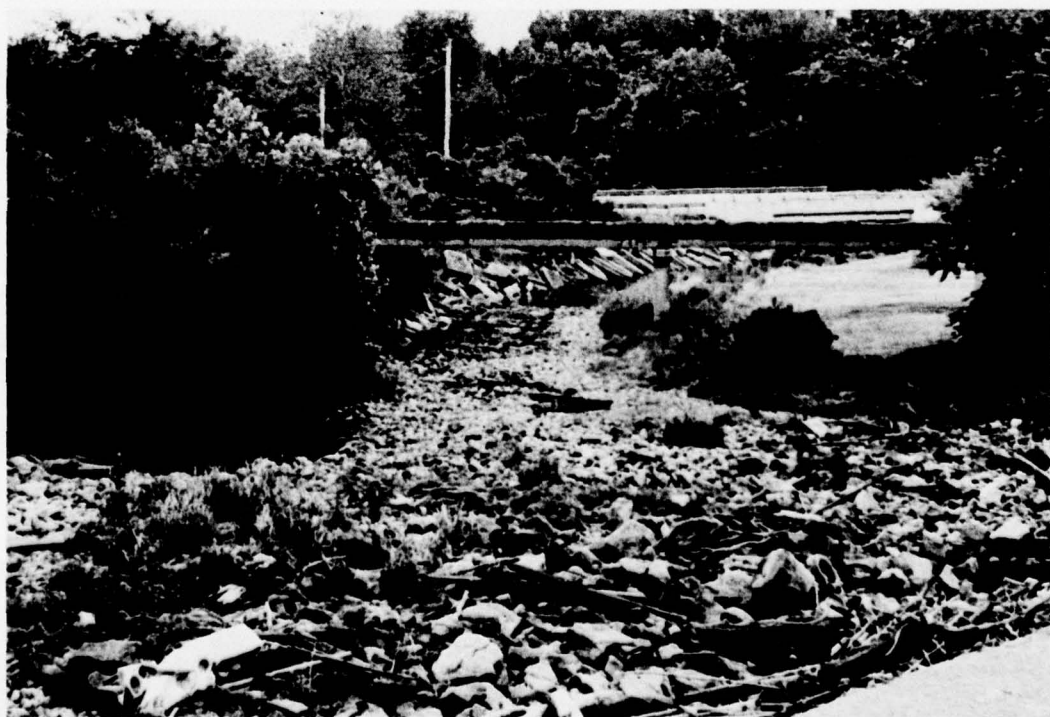
PHOTO 10

Photo 10 - Overall View of Outlet Channel Showing Debris in Foreground and Sanitary Sewer Bridging Stream Channel - 21 June 1978.
